# Assessment of Oakwood Lake Township of Medford, Burlington County, New Jersey

Paul Cooper  
[pcooper@princetonhydro.com](mailto:pcooper@princetonhydro.com)  
Project Number: 1323.001

*February 2013*

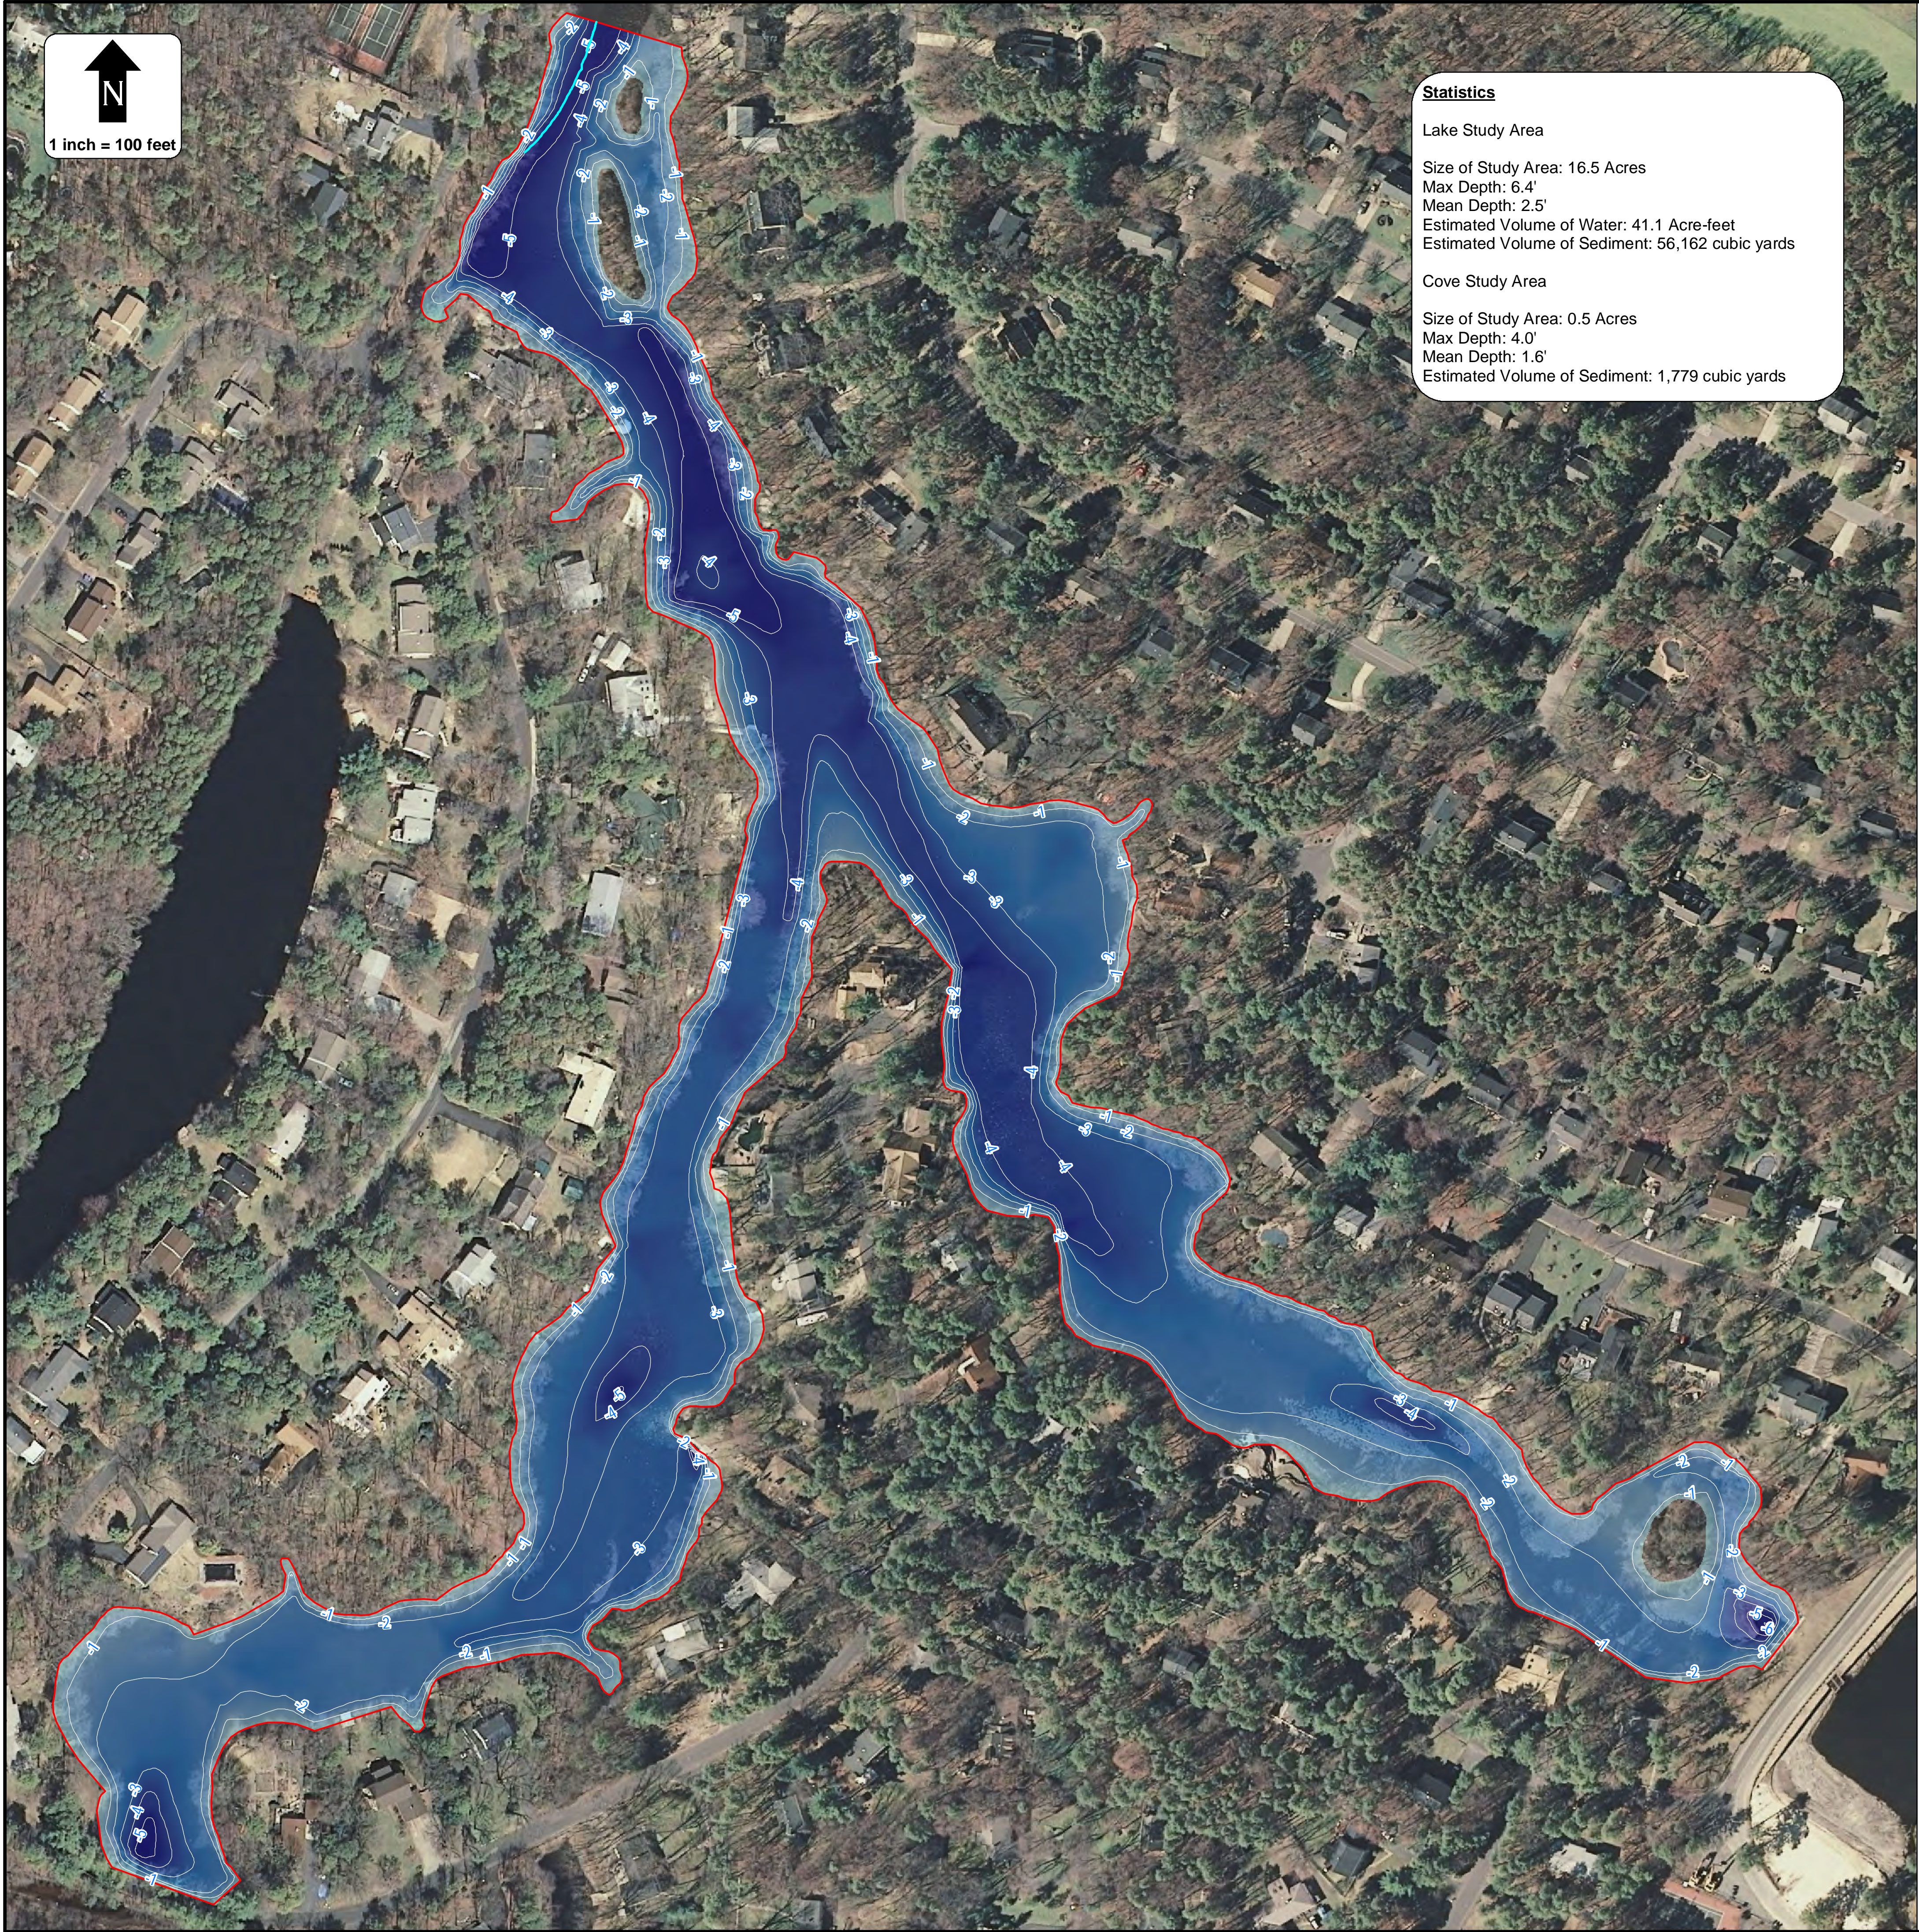
WATER DEPTH CONTOURS

In total, 16.5 acres of Oakwood Lake was assessed, in addition to the small cove (0.5 acres) just north of the swimming beach (Map 1). Maximum depth in the southern half of the lake was just 6.4 feet, recorded in the scour pool of the culvert under the dam at the head of the southeast limb, and the assessed area had an average depth of 2.5 feet. These southern limbs are quite shallow overall, yet the remnant stream channels are still evident in the maps. North of the confluence of the two limbs the lake is deeper and the littoral margins tend to be somewhat steeper. There are several small islands in the lake and the surrounding areas are quite shallow.

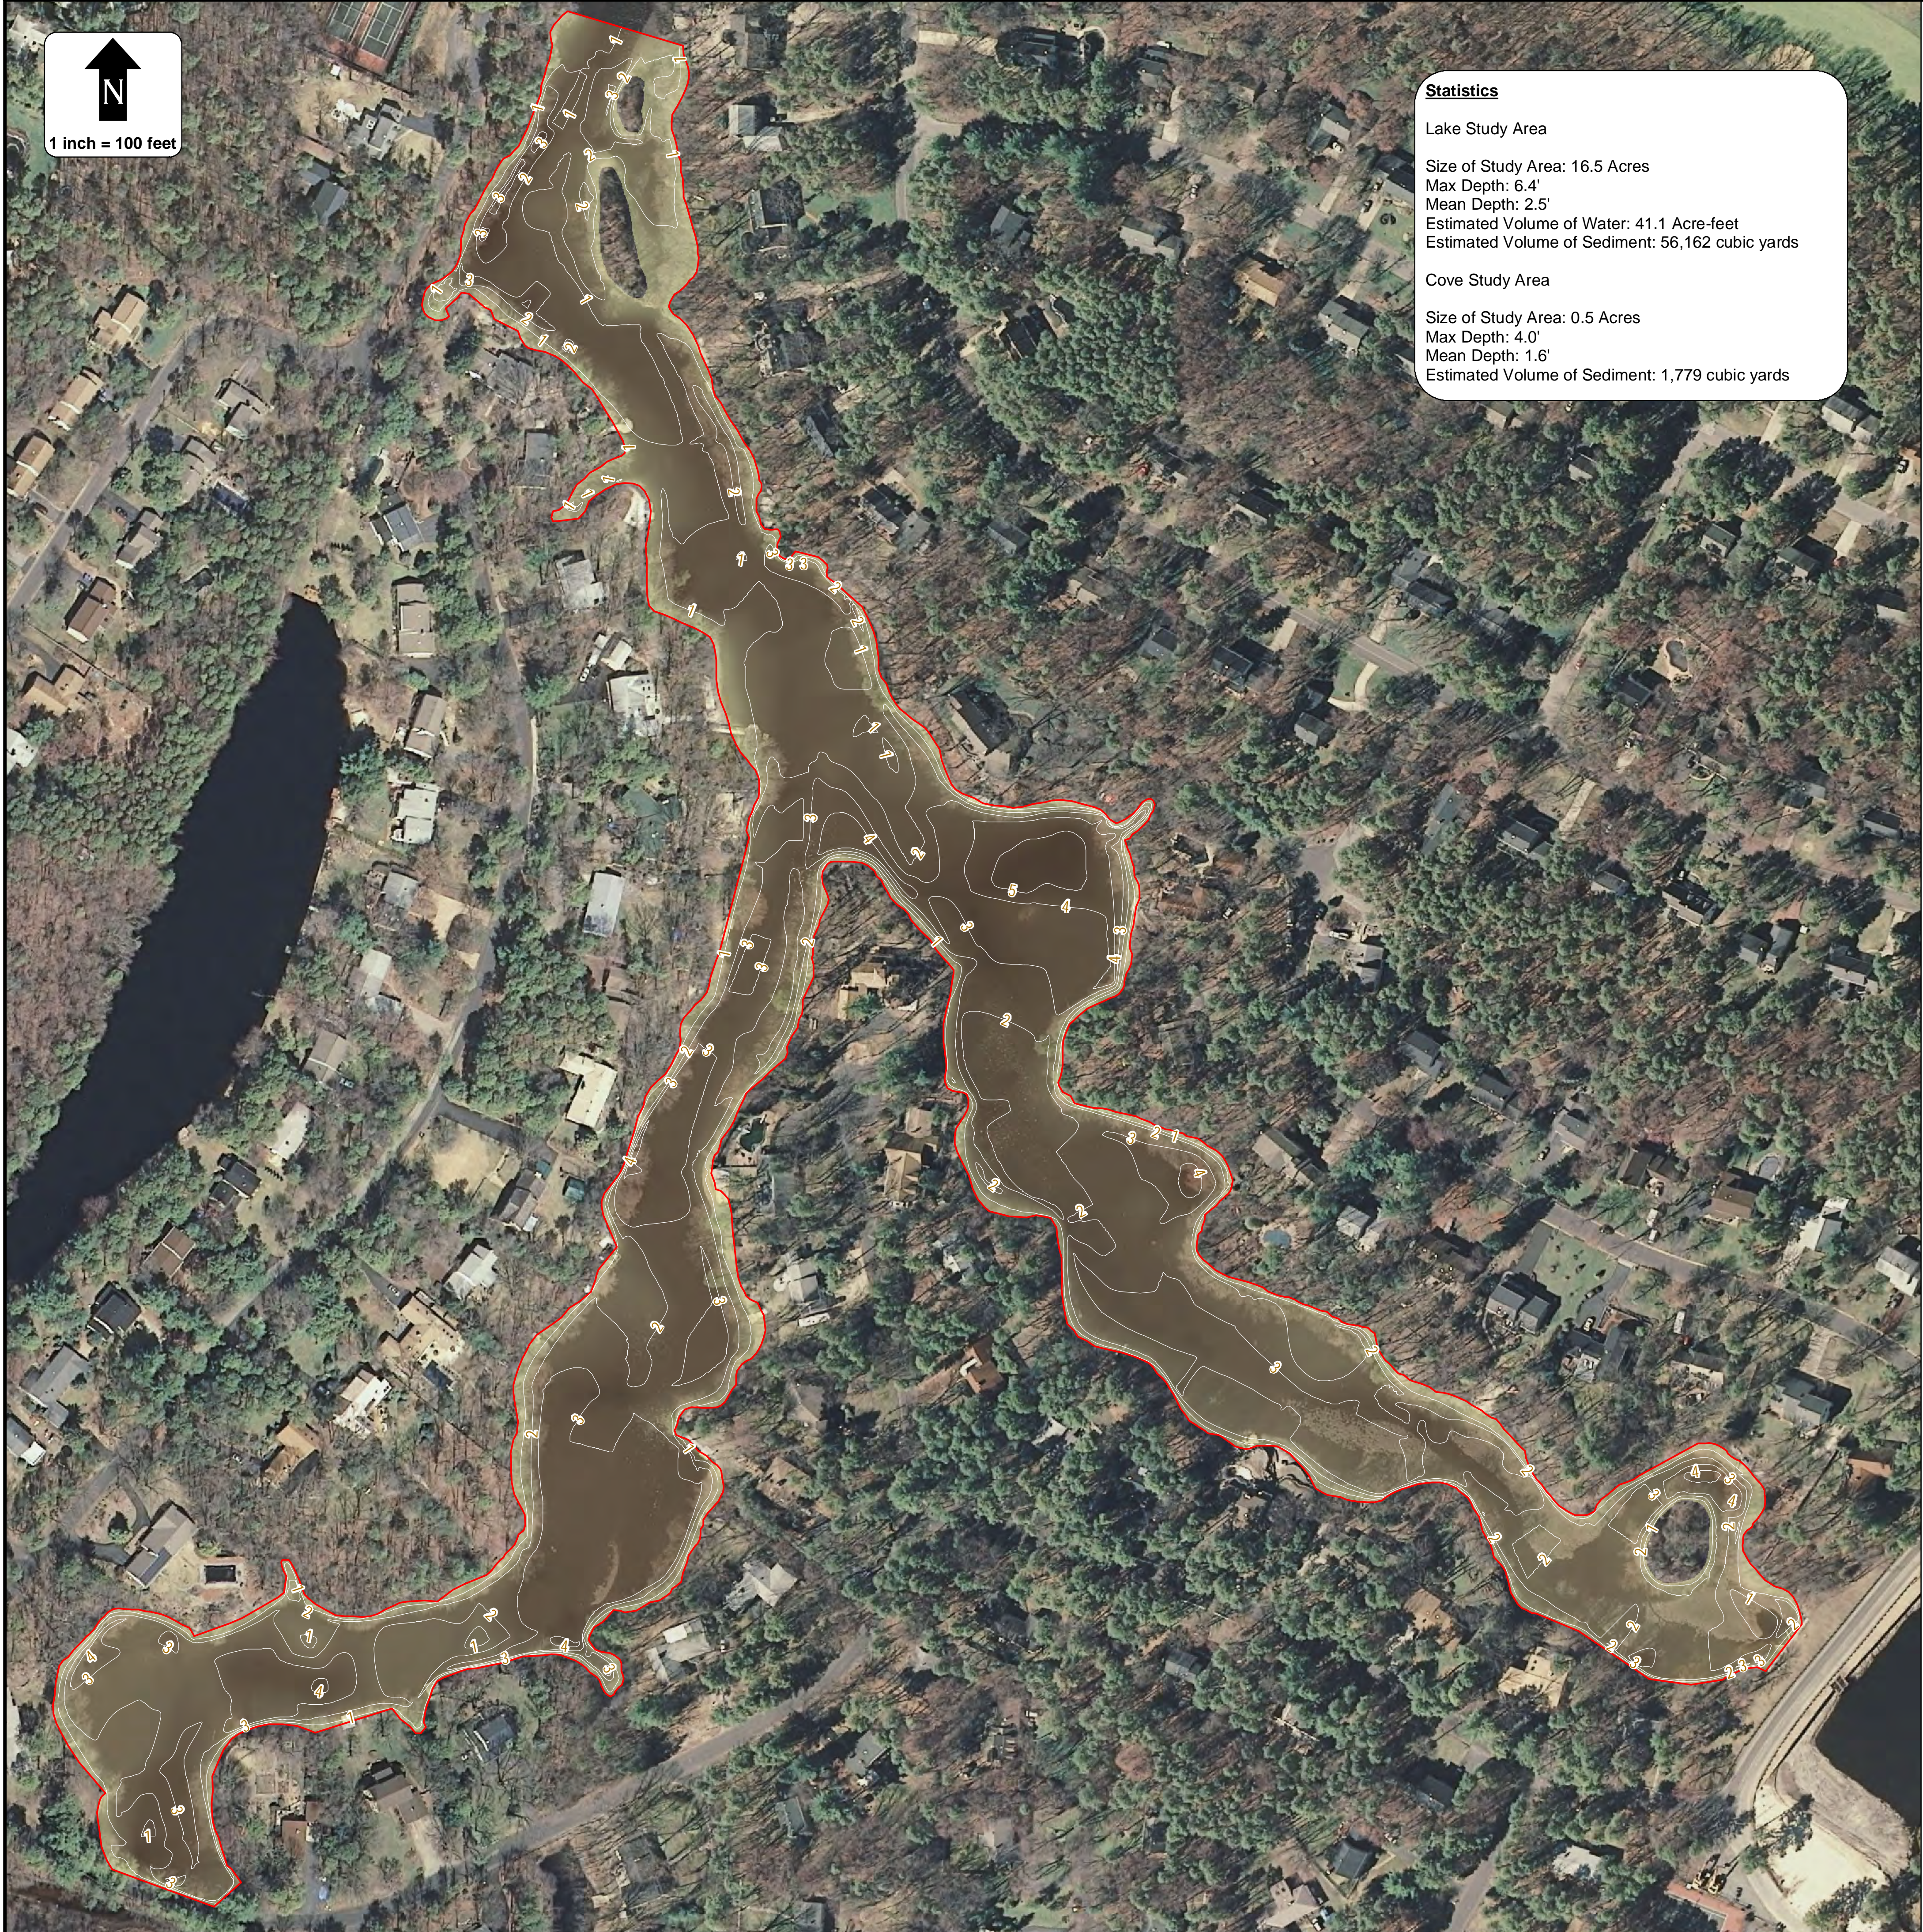
**SEDIMENT THICKNESS CONTOURS**

The sediment map is more interesting and more complex (Map 2). The calculated volume of sediment was over 56,000 cubic yards which averages to a thickness of about 2.1 feet, however the thickness is highly variable throughout the lake. The northern portion of the assessed area had decreased sediment thickness, between 1.0 and 2.0 feet for the most part, although thickness increased along the margin. Thickness was much greater in the southern limbs, with the majority of the area between 2.0 and 4.0 feet, but maximum recorded thickness exceeded 5.0 feet in spots. As with the northern portion, the accumulation tended to be somewhat thicker along the margins, although not always. It is also worth noting that the accumulation in the northwestern cove was also quite thick, but more orderly than elsewhere clearly showing the original bottom contours.

The general pattern of accumulation, namely increased accumulation in the southern limbs and along the shoreline in general, is consistent with the hydraulics and morphometry (basin shape) of the lake. First, any sediment coming in from upstream, mostly at the heads of the limbs, preferentially settles in the upper end of the lake because of the slow current in these areas. Second, the accumulation of organics along the margins is consistent with proximity to the shorelines and henceforth to the trees.

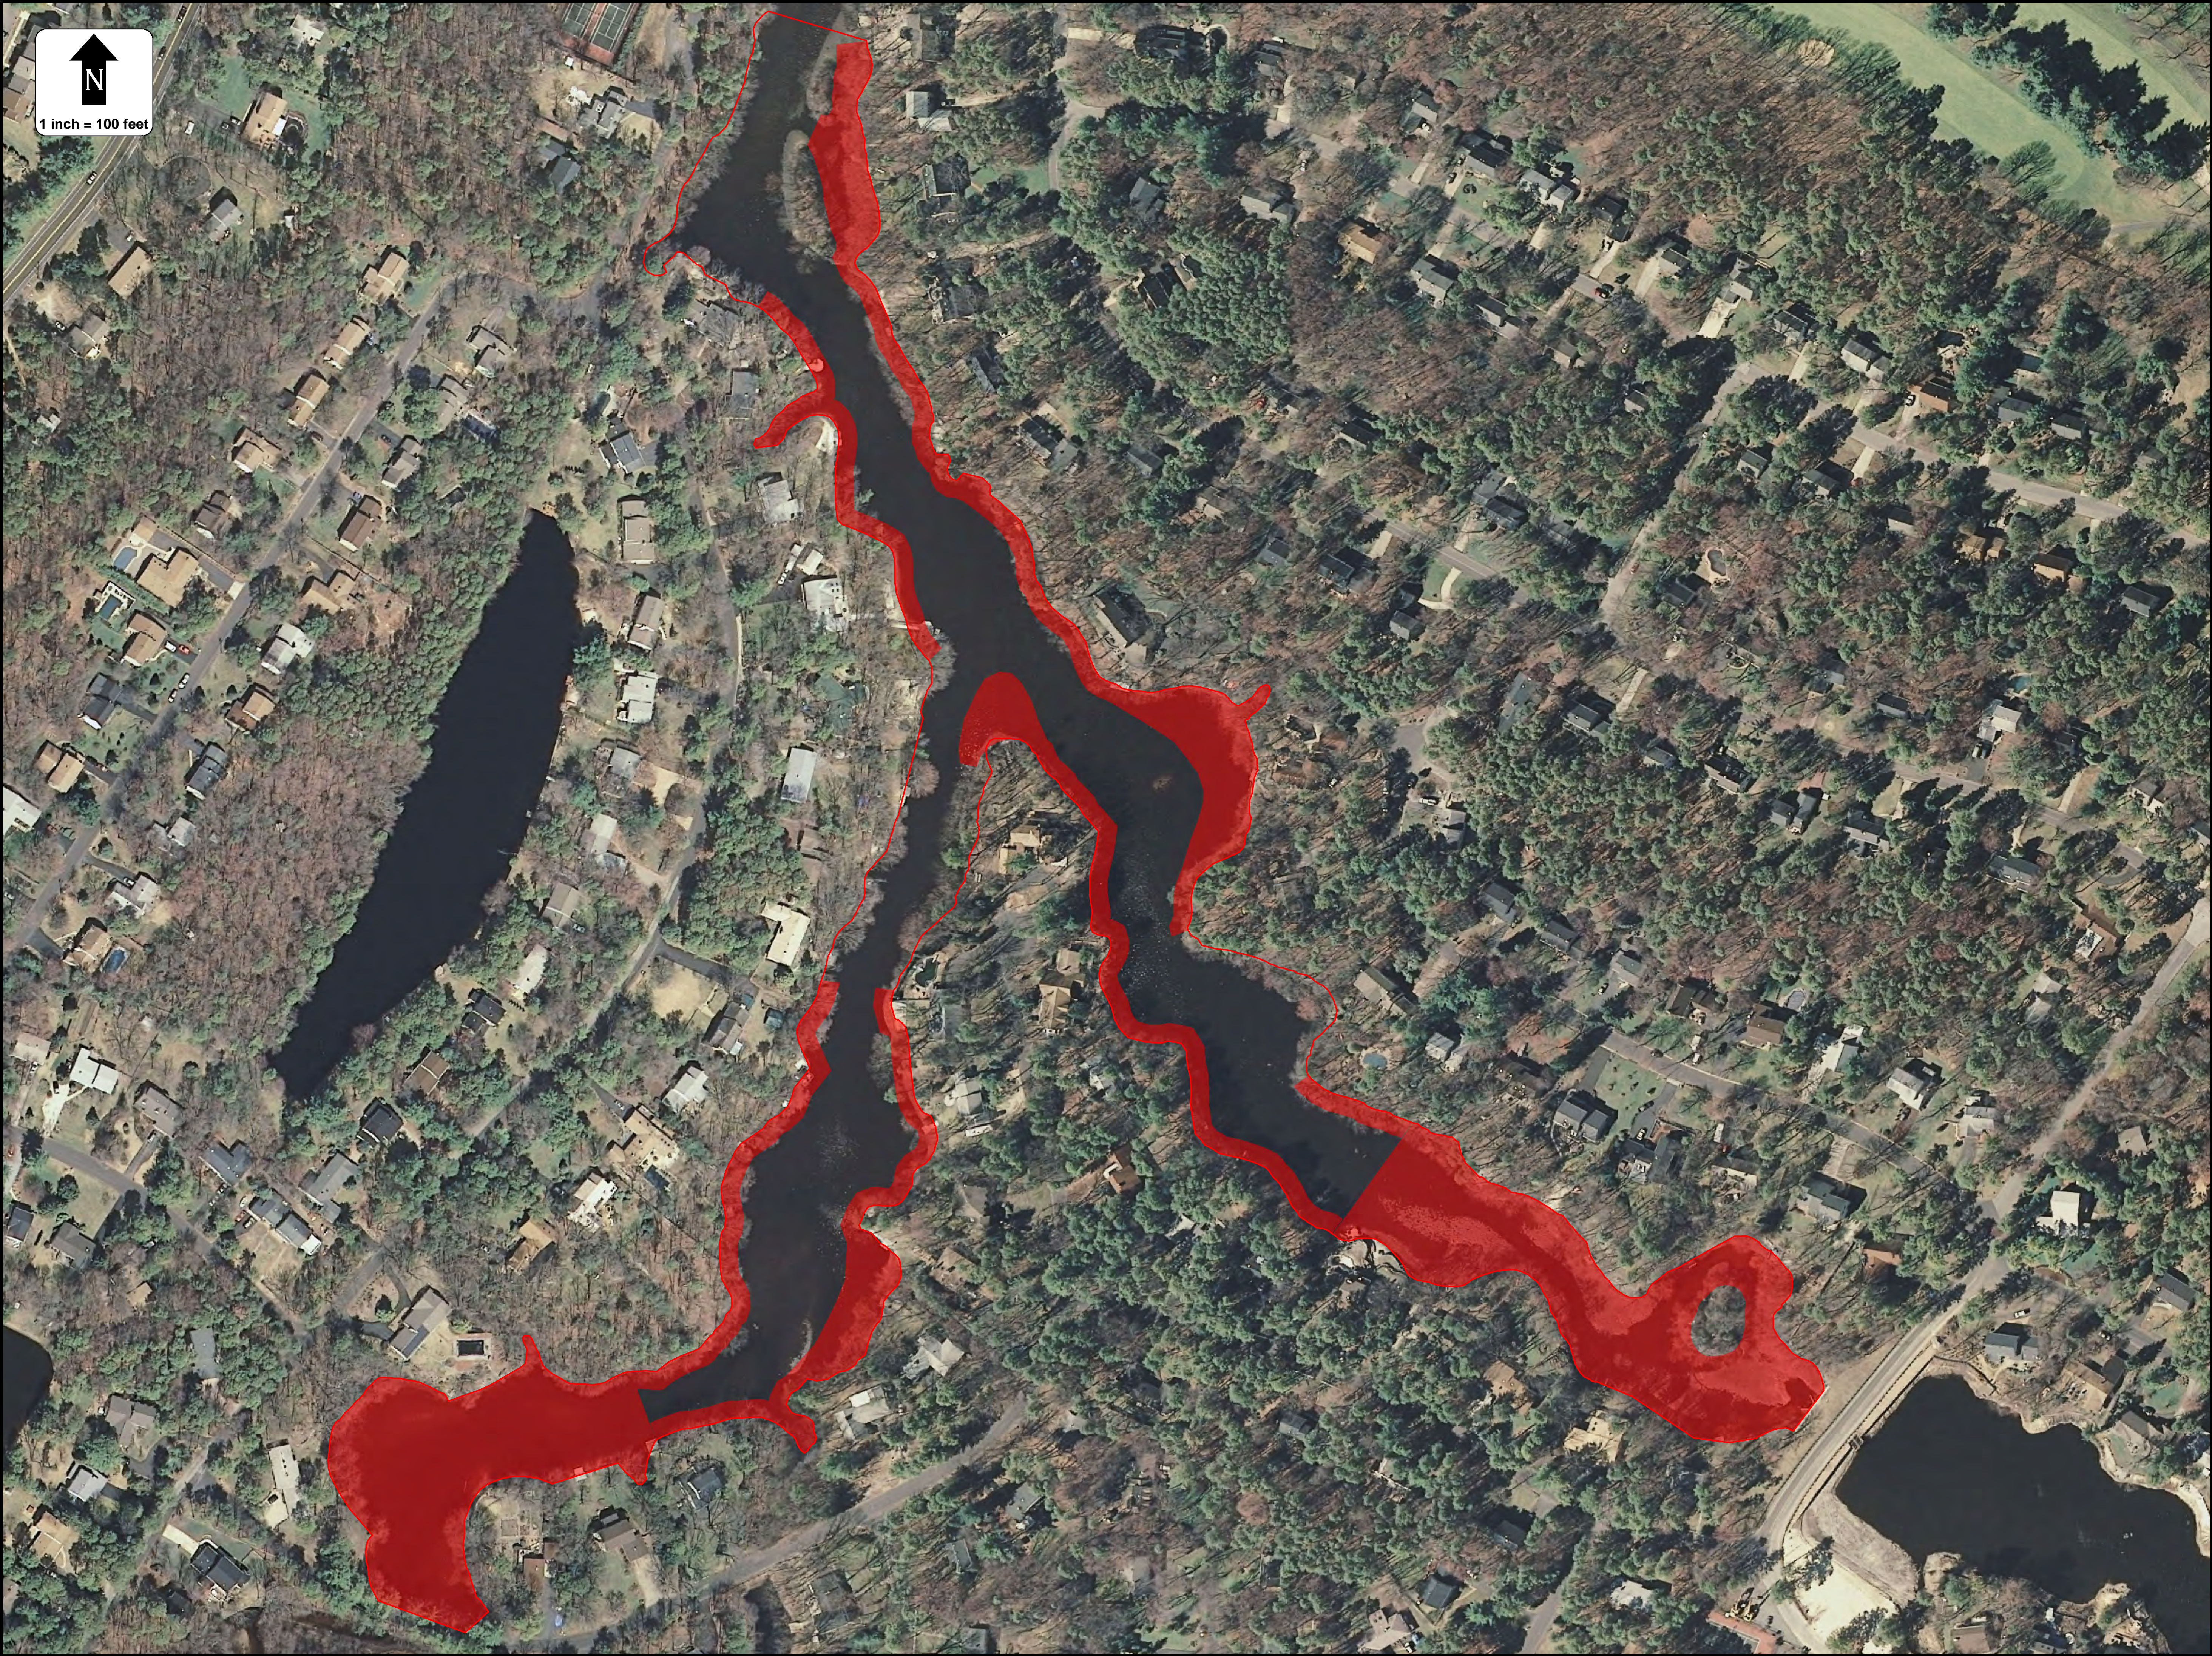
BATHYMETRIC STUDY  
TARGETED DETRITUS AREAS

Sediment type is an important consideration in the assessment as well. The organic detritus map shows that approximately 8.2 acres of the assessed area is subject to leaf litter accumulation; this is equivalent to about 50% of the total assessed area. The distribution roughly follows the sediment thickness maps and the areas of greatest continuous leaf litter accumulation are at the heads of the southern limbs: the upper 2.0 acres of the southwestern

limb and 2.4 acres in the southeastern limb. Other areas of accumulation include the shoreline margin and in the numerous small coves and shoreward of the islands. The thickness of this accumulation varies, but for the most part is less than 1.0 feet thick and is comprised of leaves, conifer needles, and branches. No aquatic plant or algal material was identifiable, but this is not surprising given the timing of the field work and because this material breaks down fairly rapidly. The coarse organic material overlies an unconsolidated or loose layer of fine organic muck with sand, dark gray to greenish-gray in color. This layer represents the more advanced decomposed stage of the surface stratum and forms the bulk of the sediments in the lake. The consolidated layer, probably the original stream bed or flood plain is silty-clay. There was one area of significant sand accumulation at the outfall of Lower Birchwood Lake (identified on most maps as Timber Lake) as well an outfall coming from the northeast near the same location. The scour pool at the culvert also had a hard bottom, which may indicate this area was stabilized with riprap at some point.

Therefore, this leaves two viable options: hydroraking and dredging. Hydroraking is focused solely on the removal of accumulated detritus and plants and plant biomass. If the hydroraking is consistent with the removal of this type of material it can be performed without a permit. Hydroraking would likely be conducted with either a large rake or even a clam-shell or other bucket-type attachment deployed from an amphibious vehicle. Based on the composition of the sediment and the accumulation of leaf litter and other organic detritus throughout much of the highlighted areas this would result in an improvement in depth of only up to a foot. There are certainly areas where depth improvements would be greater, especially in some of the small coves or around docks and other encroachments that capture debris, but by and large the area wide use of hydroraking would probably provide limited relief. Once hydroraking veers into the removal of sediment as opposed to coarse organics or at a depth in the sediment where there are no longer recognizable leaves, branches, or root biomass, this becomes dredging and thus is a regulated activity.

Still, hydroraking could be of some use in Oakwood Lake. Given the relatively limited access to the lake at the swimming area, the distance to the head of the upper limbs (around 2,800 feet), and the lack of obvious spoils disposal points hydroraking would require the use of a barge to move hydroraked material as well as the amphibious vehicle. Using such a set-up approximately 0.5 acres could be hydroraked in a day. The cost would be approximately \$1,500 to \$2,000 per day for the amphibious vehicle and another \$200 per day for the use of the barge. The best success using this approach would be to target smaller areas or those considered higher visibility or otherwise higher priority as decided by the OLCA.
