# Assessment of Oakwood Lake Township of Medford, Burlington County, New Jersey

Paul Cooper  
[pcooper@princetonhydro.com](mailto:pcooper@princetonhydro.com)  
Project Number: 1323.001

*February 2013*

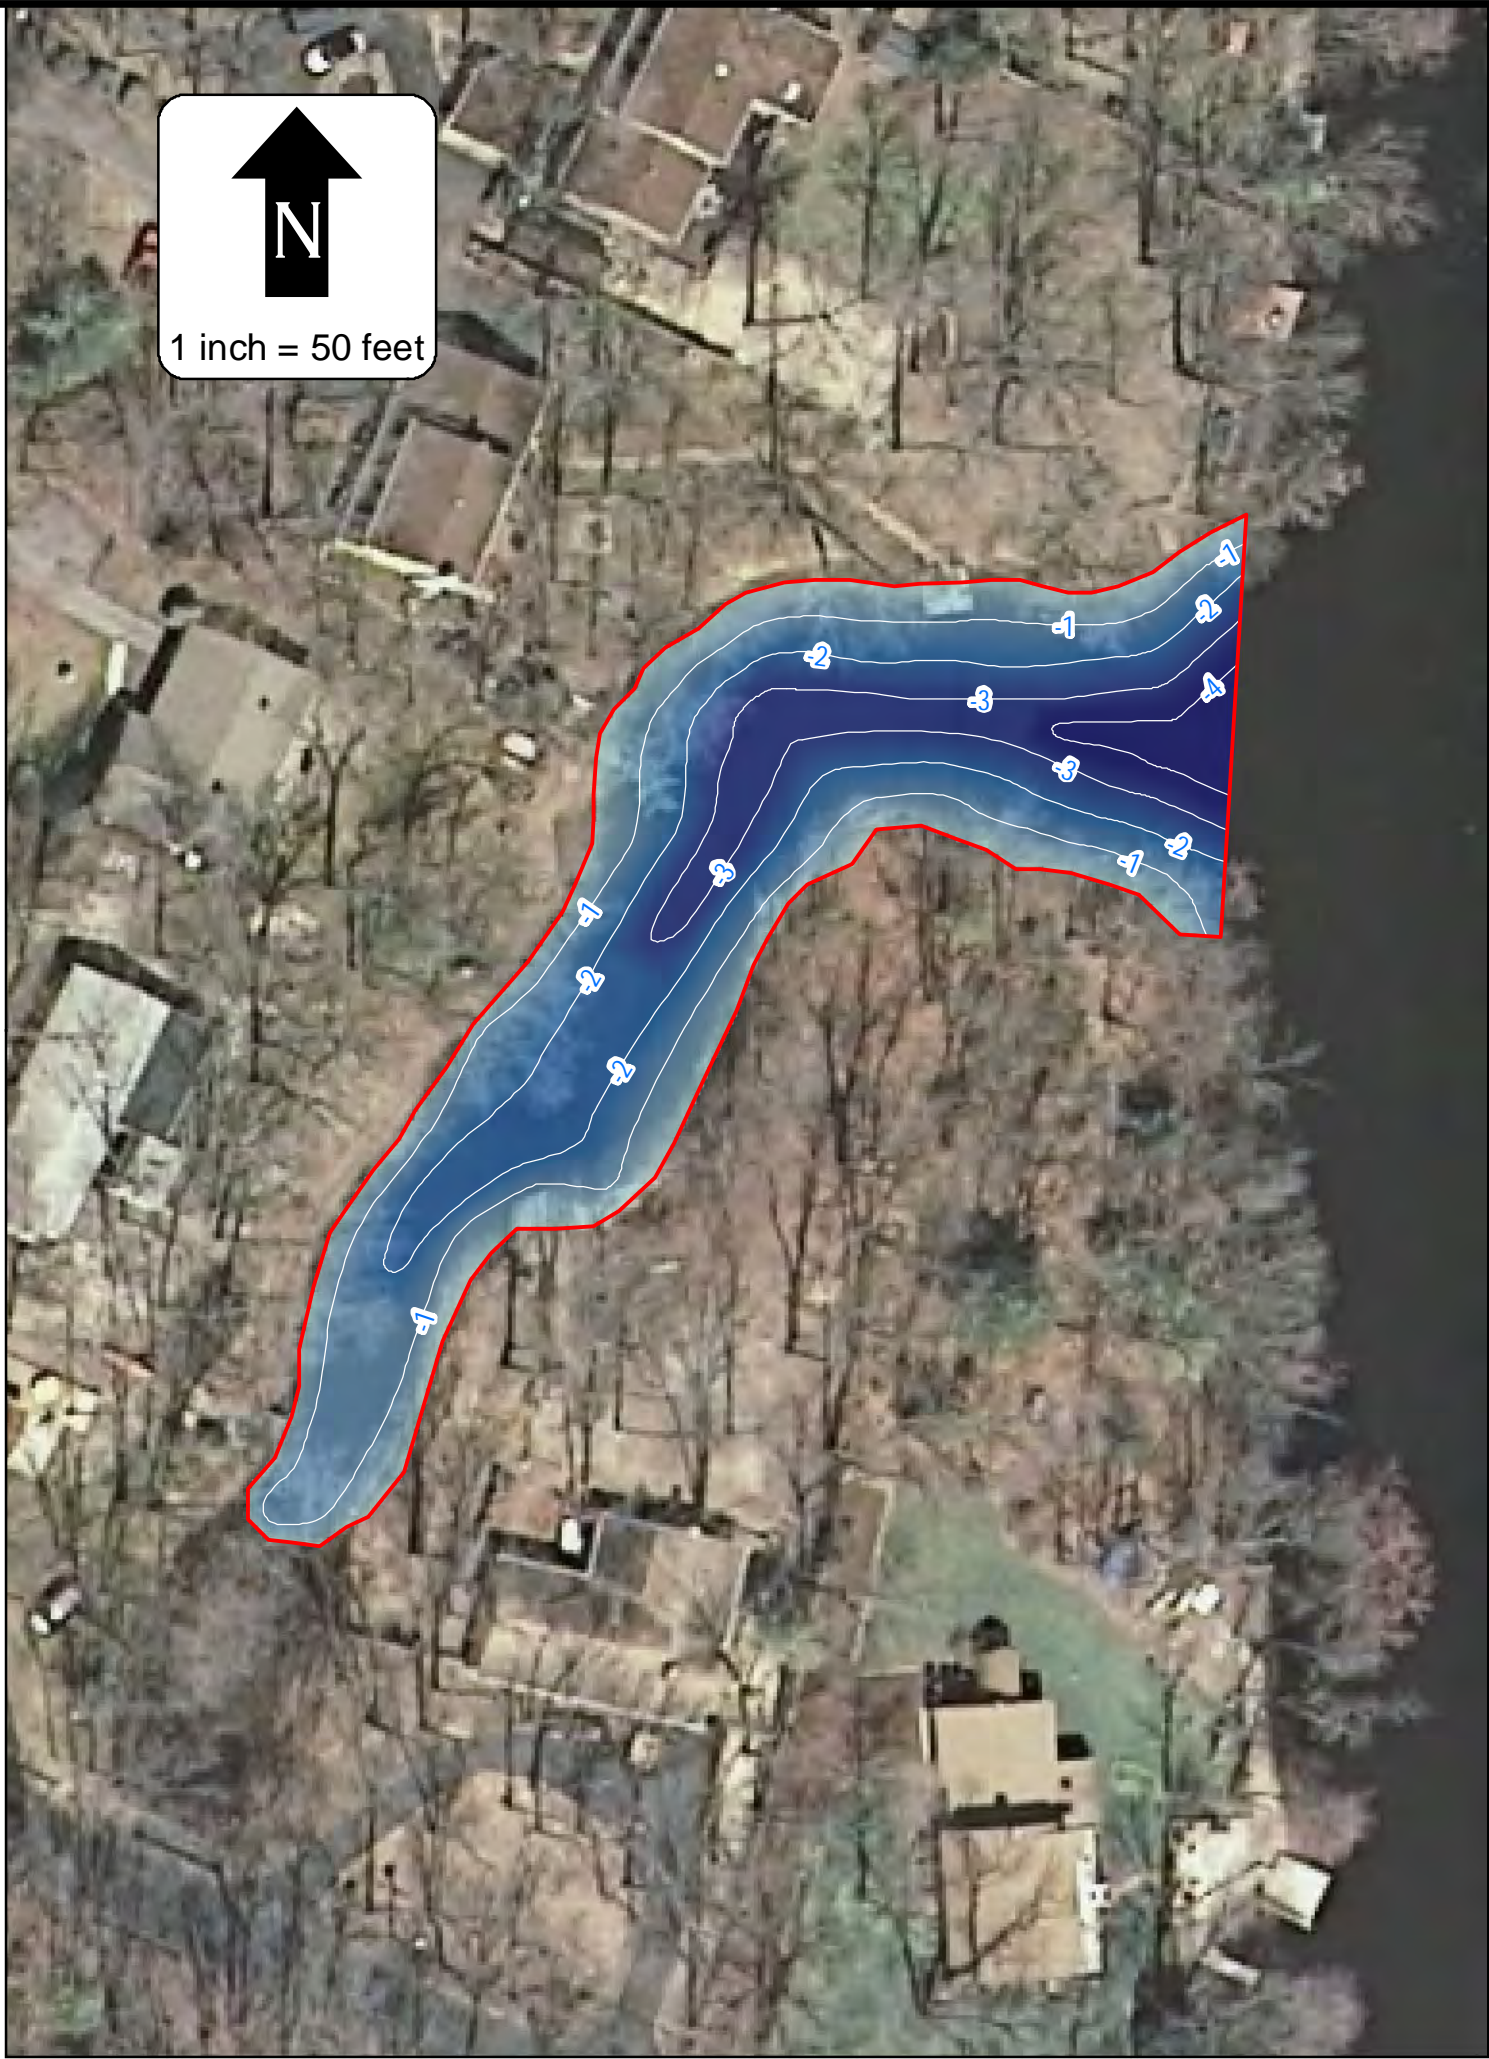
**Cove Study Area**

Size of Study Area: 0.5 Acres  
Max Depth: 4.0'  
Mean Depth: 1.6'  
Estimated Volume of Sediment: 1,779 cubic yards

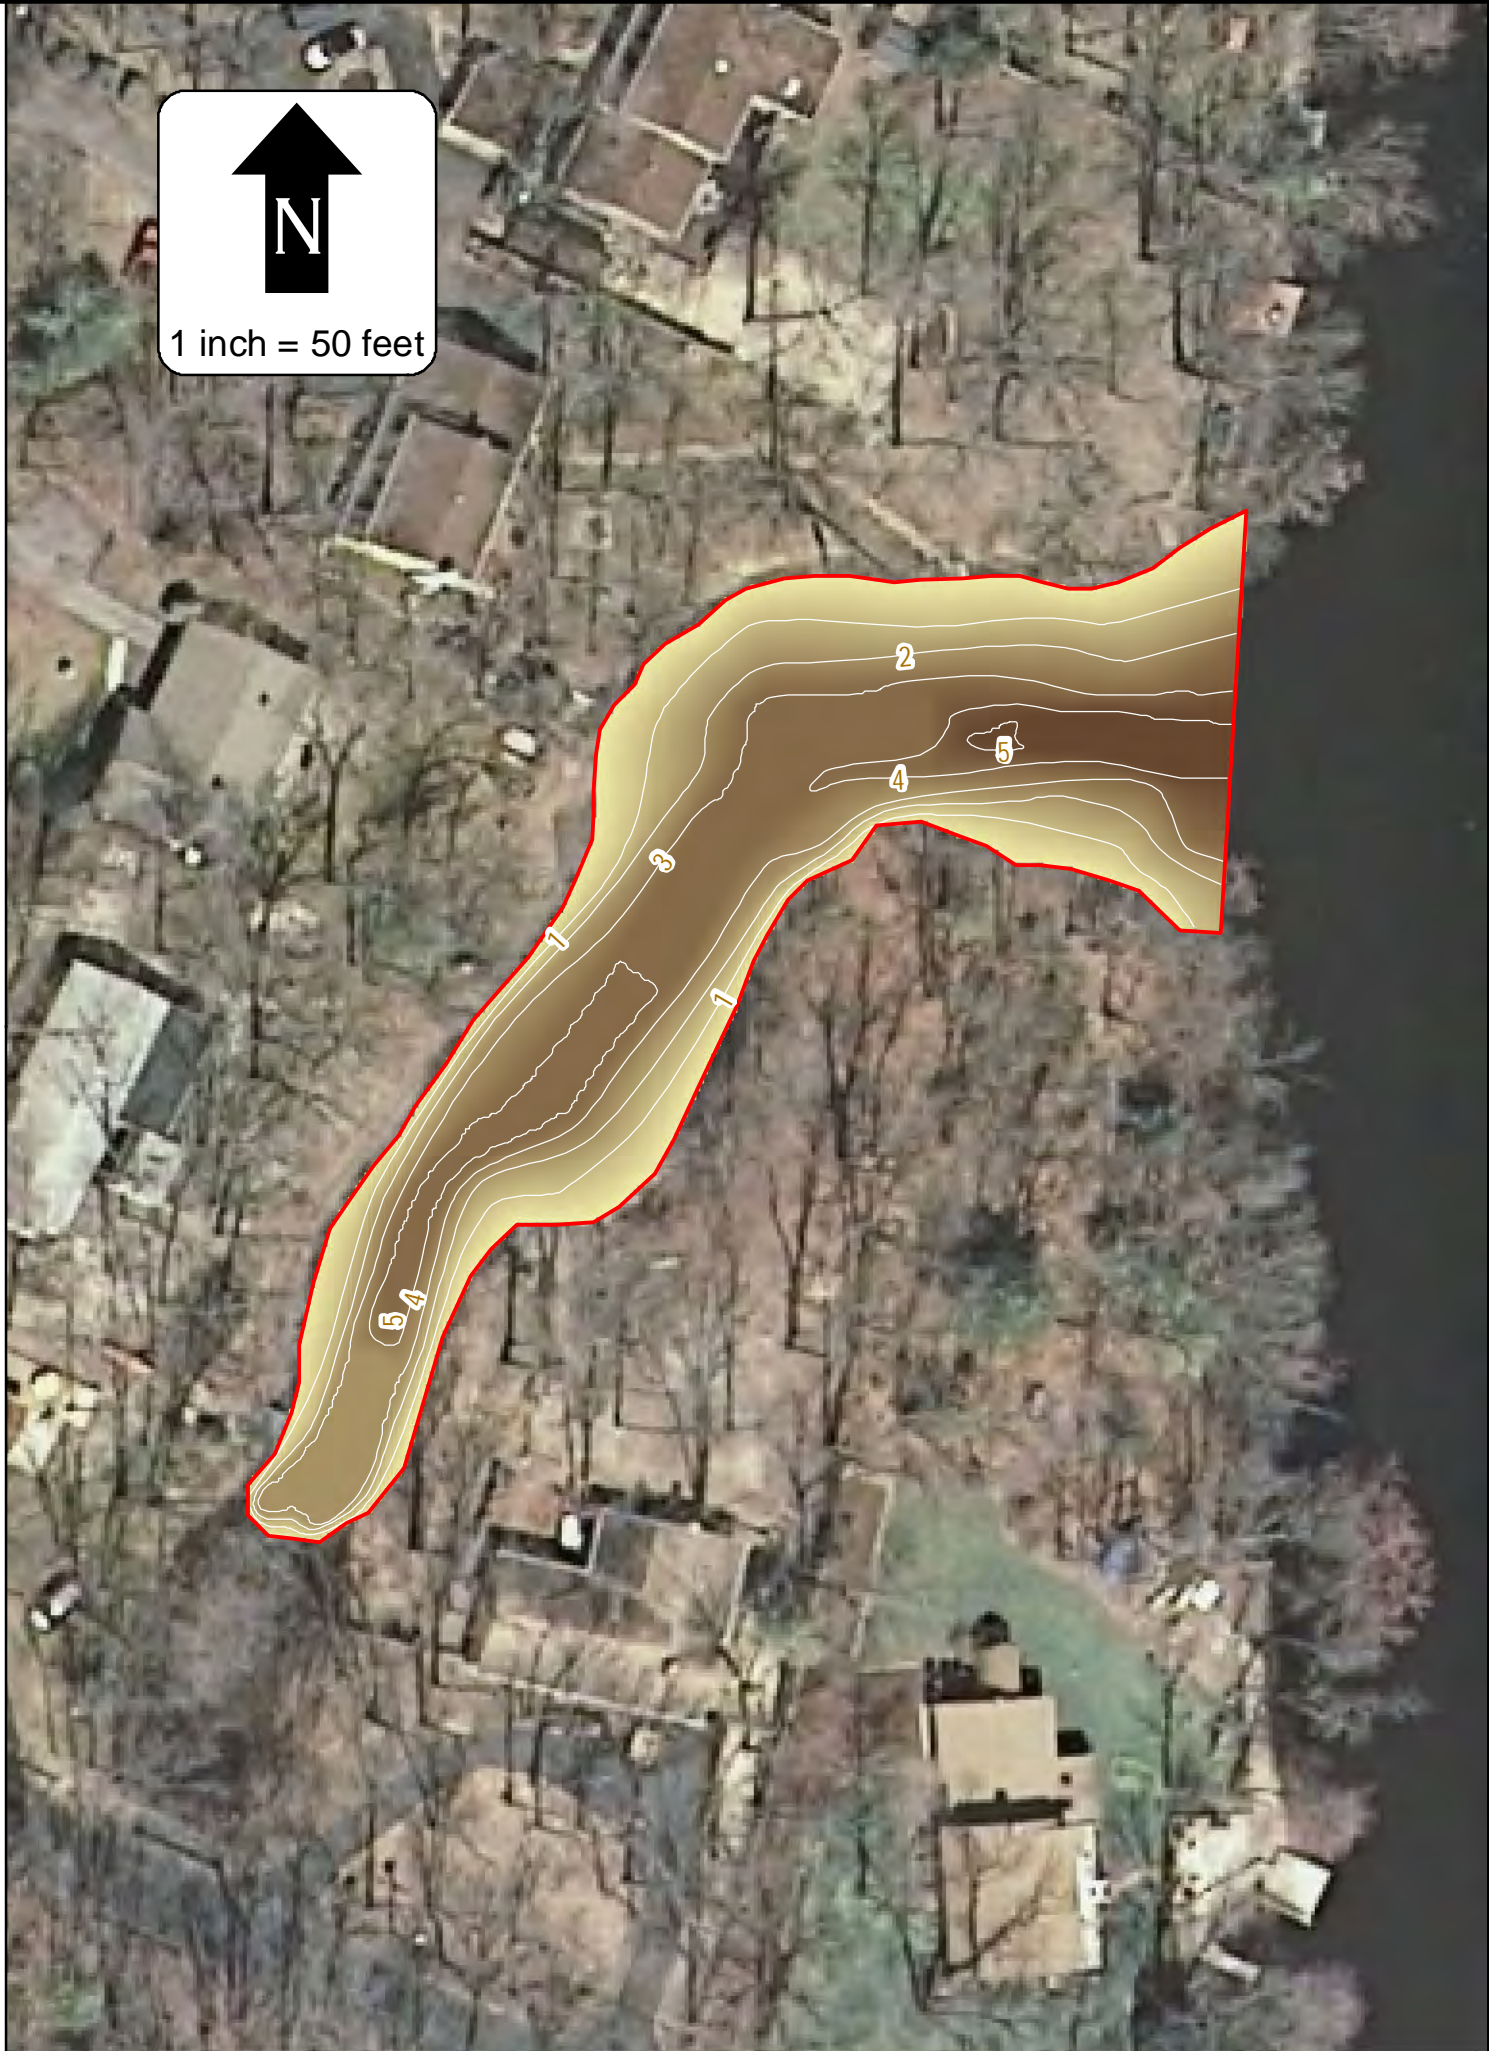
**Cove Study Area**

Size of Study Area: 0.5 Acres  
Max Depth: 4.0'  
Mean Depth: 1.6'  
Estimated Volume of Sediment: 1,779 cubic yards
